**MANDATORY SERVICE BULLETIN**

NO. 0002/PAGE 1

**SUBJECT: DUKES INC. ELECTRIC FUEL BOOST PUMPS**

**SUBJECT:** FUEL - DUKES INC. ELECTRIC FUEL BOOST PUMP INSPECTION AND OVERHAUL/REPLACEMENT.

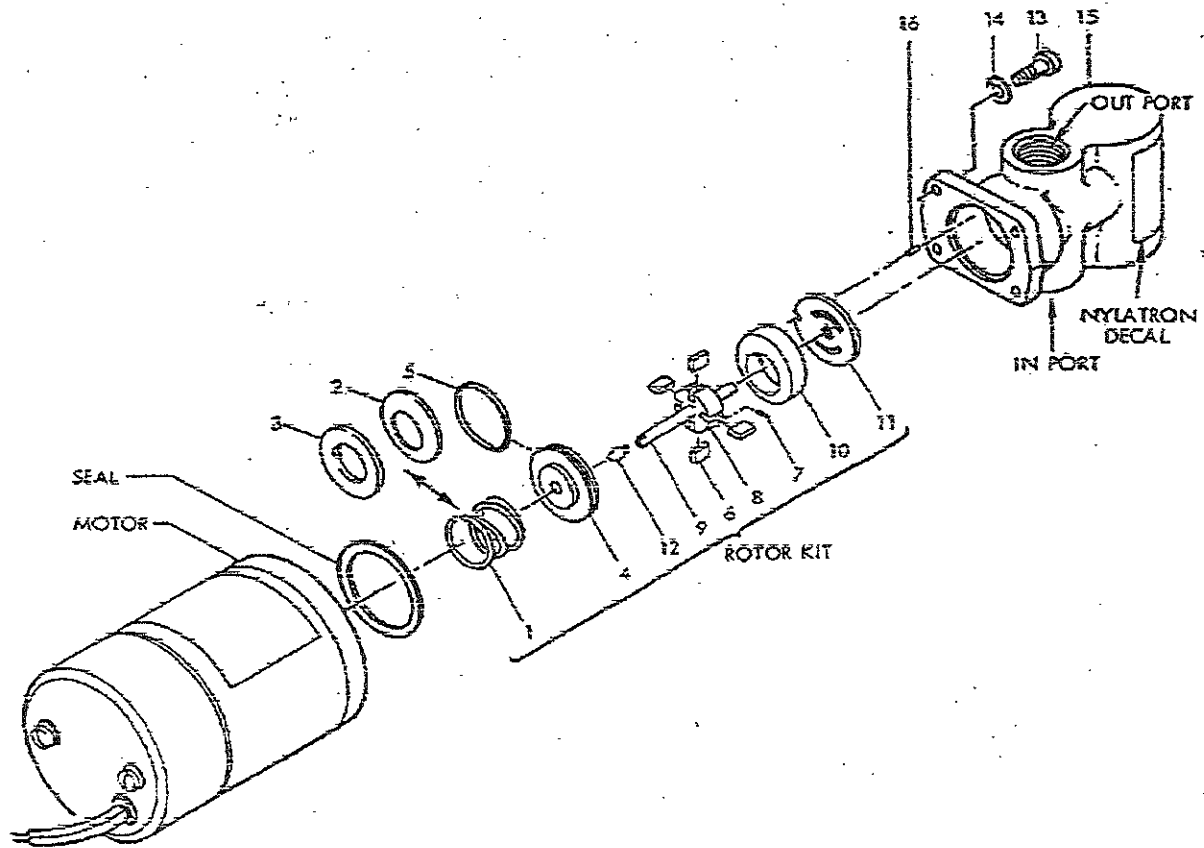
**DUKES 4140 SERIES  
ELECTRIC FUEL BOOST PUMP**

**PURPOSE:** THIS BULLETIN IS NECESSITATED BY THE FACT THAT SOME OF THE CARBON VANES IN THE OLDER PUMPS HAVE SHATTERED DUE TO THE INGESTION OF CONTAMINATES INTO THE PUMP. IN SOME CASES THESE PARTICLES HAVE FOUND THEIR WAY TO THE MAIN ENGINE FUEL PUMP AND CAUSED THE REED TYPE VALVES TO MALFUNCTION, RESULTING IN REDUCTION OR LOSS OF ENGINE POWER. COMPLIANCE IS ACCOMPLISHED BY THE INSTALLATION OF DUKES ROTOR KIT 2140-220. THIS KIT WILL REPLACE CARBON VANES WITH VANES MADE OF NYLATRON, WHICH IS EXTREMELY RESISTANT TO SHATTERING (SEE ITEM NO. 6.)

**NOTE:** ANY PUMP EITHER NEW OR OVERHAULED BY DUKES INC. AFTER 1/1/88 ALREADY CONTAINS NYLATRON VANES. THESE PUMPS CAN BE IDENTIFIED BY EITHER A YELLOW DECAL ON THE BASE OF THE PUMP OR BY THE LETTERS "NV" FOLLOWING THE PART NUMBER. PUMPS IDENTIFIED AS CONTAINING NYLATRON WILL NOT REQUIRE SERVICE UNTIL THE TEN YEAR TBO HAS BEEN REACHED.

**COMPLIANCE:** COMPLIANCE MUST BE ACCOMPLISHED BY EITHER REPLACEMENT WITH A NEW PUMP, OR OVERHAUL OF THE EXISTING PUMP BY DUKES INC. OR AN FAA CERTIFIED REPAIR STATION (REQUIRED COMPONENT PARTS MUST BE PURCHASED FROM BEECHCRAFT OR THEIR AUTHORIZED DEALERS.) COMPLIANCE IS MANDATORY WITHIN THE NEXT 100 HOURS OR NOT LATER THAN 6/1/94.
